Keystone Fifth Wheel - Sidewall Crack Repair

This process describes the safe and proper procedure to repair any unit which experiences a crack at the bottom corner of a slideout at the gooseneck of a 5th wheel by opening the side wall to add reinforcement. This Keystone Service Bulletin explains how to perform the repair.

Model and Serial Numbers Included: 2020-2022 Avalanche and Alpine Fifth Wheel Units 2020-2023 Montana, High Country Montana and Fuzion Fifth Wheel Units

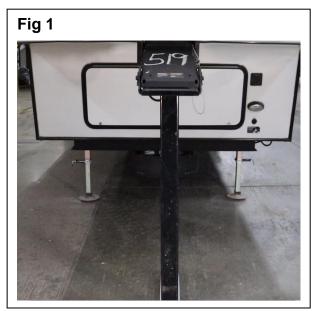
Remove the pre-bent trim from the bottom and both sides of the front cap. **See Figure 2**

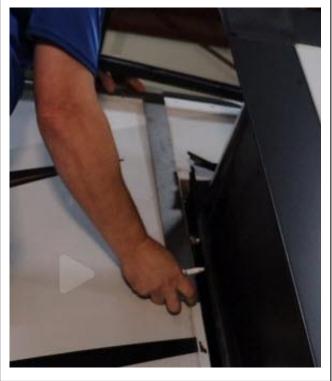
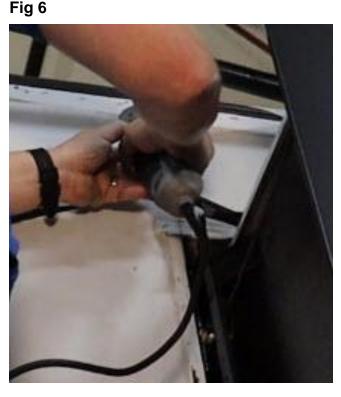
the Dremel tool to cut the upper expansion joint even with the slideout opening all the way to the roof line. The cut should only leave a 1/16" gap for the t-molding to tightly fit into. **See Figure 5 and Figure 6**

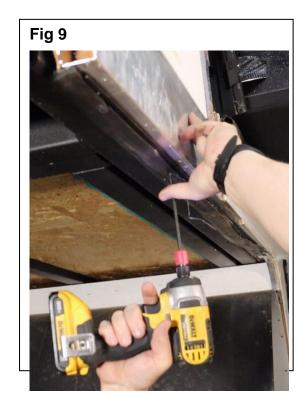
Remove the Bulkhead cover to access and remove the screws from the sidewall straps that hold the sidewalls in place on both sides of the RV. **Figure 9** Check for screws on the backside of the steel frame tube, if screws are found remove them. **See Figure 10** Inspect the sidewall straps for cracks **Figure 9** - if cracked contact LCI to perform repairs to sidewall straps first.

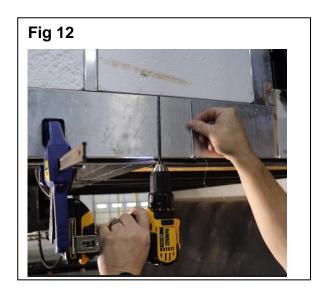
See Figure 12

Inspect the 3 sidewall tubes for missing wood. If wood is missing stuff the tubes on both sides of the RV using 1 $\frac{1}{4}$ " x 1 $\frac{1}{4}$ " wood and 1 $\frac{3}{4}$ " x 1 $\frac{1}{4}$ " wood which can be ripped down out of 2x4's or 2x6's Typical length of the wood is 53". If the cap is in the way just release the quick clamp holding the cap out to allow room to insert the wood. (See Video/Link Top of Front page) Use a hammer if necessary to drive them in. See Figure 11 After all tubes have wood installed, pull the sidewall tight to the frame with a clamp and use a 3/16th drill bit to predrill up through the exiting screw holes in the sidewall strap through the wood stuffed tubes, then install #14 X 5" screws.

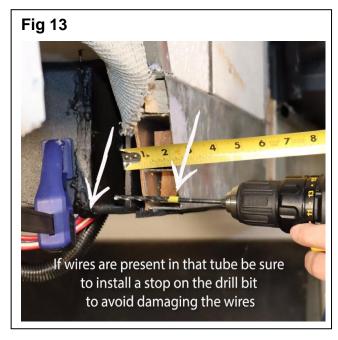
Secure the sidewall to the chassis frame. If wires are present in that tube be sure to install a stop on the drill bit to avoid damaging the wires. **See Figure 13** Using a 7/32" drill bit pre-drill holes through the sidewall and through the 2X6 LCI steel tube. Then add (4) 1/4"-20X3" screws horizontal through the wood stuffed tubes into the center of the steel tube. **See Figure 14**

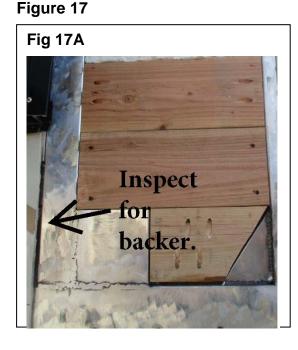
Cut the aluminum skirt metal to fit from the slideout opening to the front of the sidewall and down to the bottom of the sidewall tube. Be sure the metal will cover the 2x6 boards that will go in for the repair. **See Figure 16**

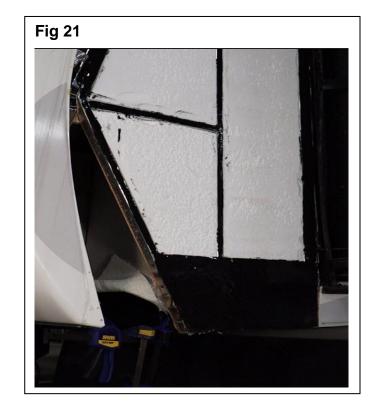
Use the 2 part epoxy again on the aluminum studs, spread this out in an even layer 1/8" thick. **See Figure 21** Then use the Lavanture adhesive KRV# 346665 on the Styrofoam, spread this out in an even layer 1/8" thick. **See Figure 22** Install the new filon in place and add screws to front filon perimeter, the slideout opening perimeter and at the top, the bottom will have to be clamped. Clean off any glue now so it does not dry on the filon. Brace from top to bottom using 2x4's and carpet and allow to dry overnight. **See Figure 23 and Figure 24**

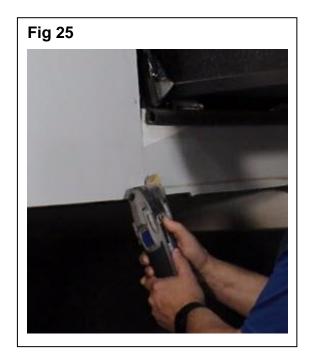
The next day remove the bracing. Remove all the screws used on the edges. Inspect the filon at the edges and trim any excess sidewall skin if necessary. Recut the expansion joints to have the room to then install both top and bottom expansion joint covers with silicone. **See Figure 25 and Figure 26**
